# Storm Induced Beach Profile Changes along the Coast of Treasure Island, West-Central Florida, U.S.A.

A thesis submitted in partial fulfillment  
of the requirements for the degree of  
Master of Science  
School of Geosciences  
College of Arts and Sciences  
University of South Florida

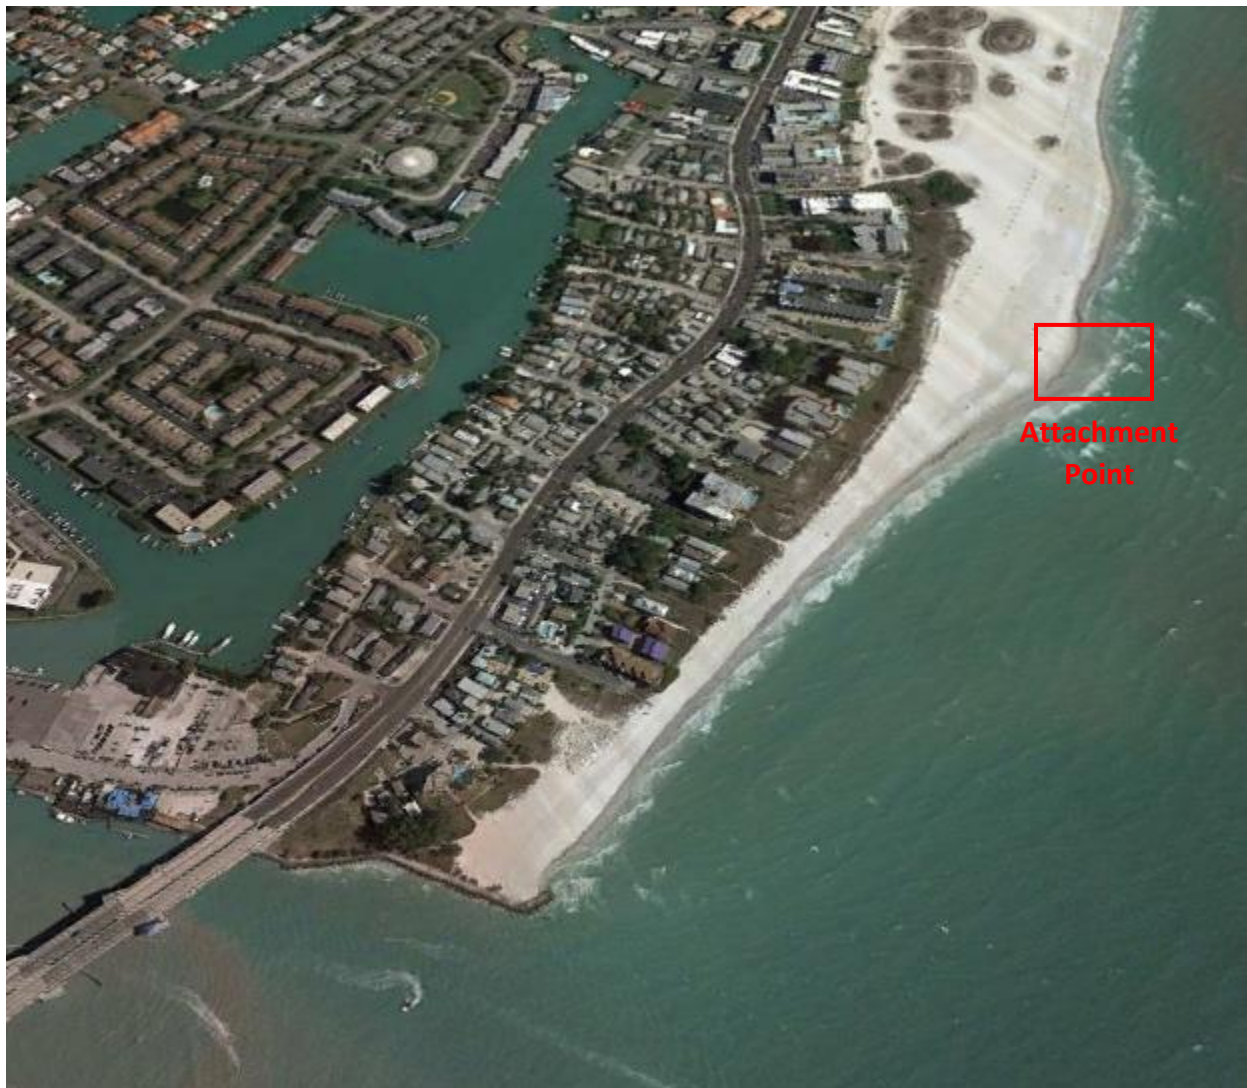
**Figure 2.** John's Pass ebb-tidal shoal and attachment point.

mixed energy inlet with a flood-tidal delta that is stable with large percentage of vegetation cover (Barnard, 1998). As shown in Figure 1, the portion of Boca Ciega Bay, directly landward of John's Pass, is larger and not dissected by man-made islands and compared to the portion landward of Blind Pass (Wang et al., 2011). The large ebb-tidal delta is skewed to the south as controlled by the southward longshore sediment transport (Wang et al., 2011). The downdrift attachment point is located approximately 1 km south of the inlet (Figure 2).

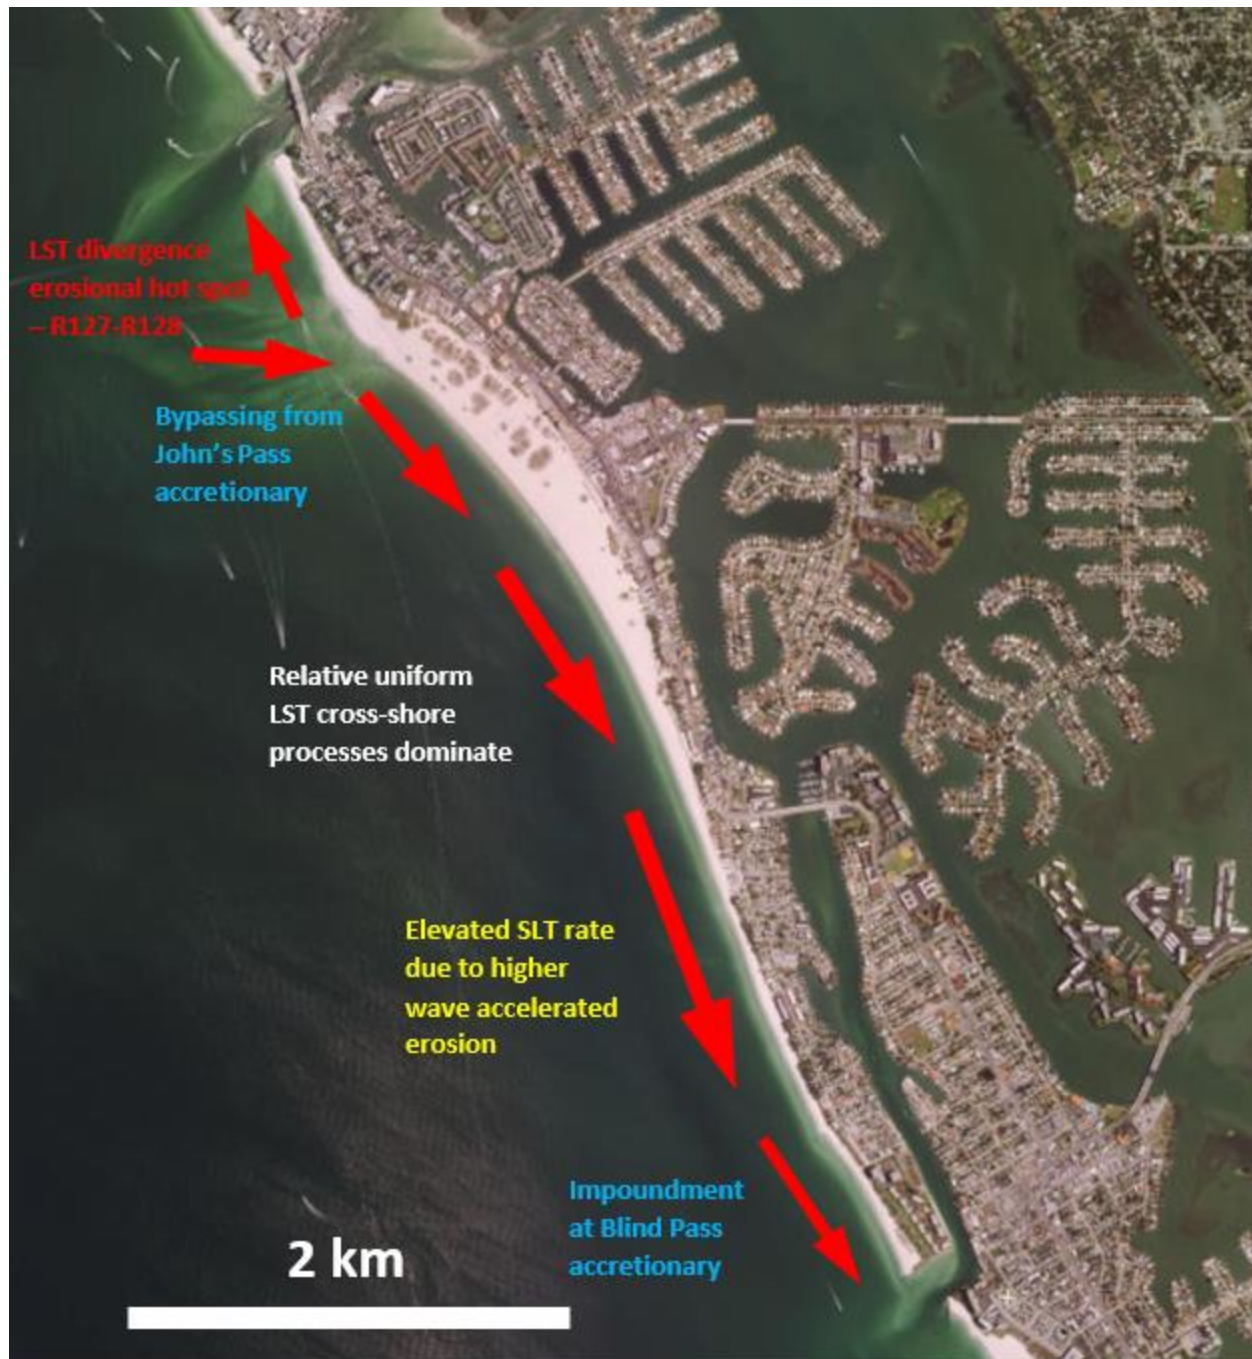
**Figure 3.** Generalized trend of net longshore sand transport (LST) along Treasure Island.

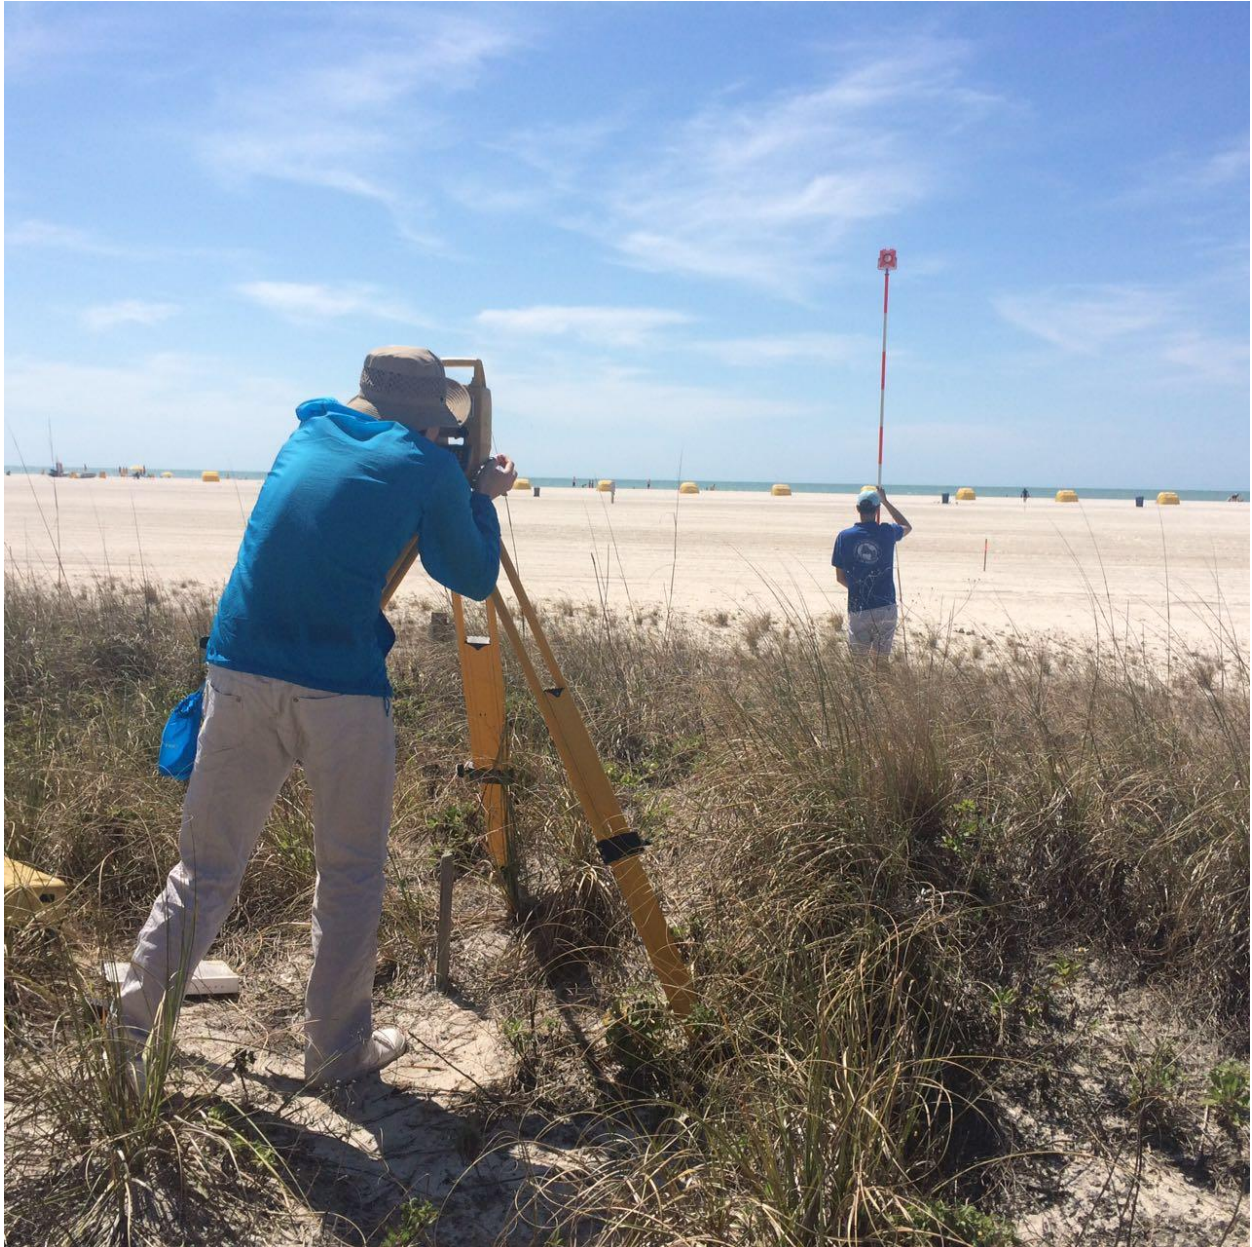
**Figure 4.** Survey procedures include the use of an electronic level-and-transit total station and a 4-m survey rod.

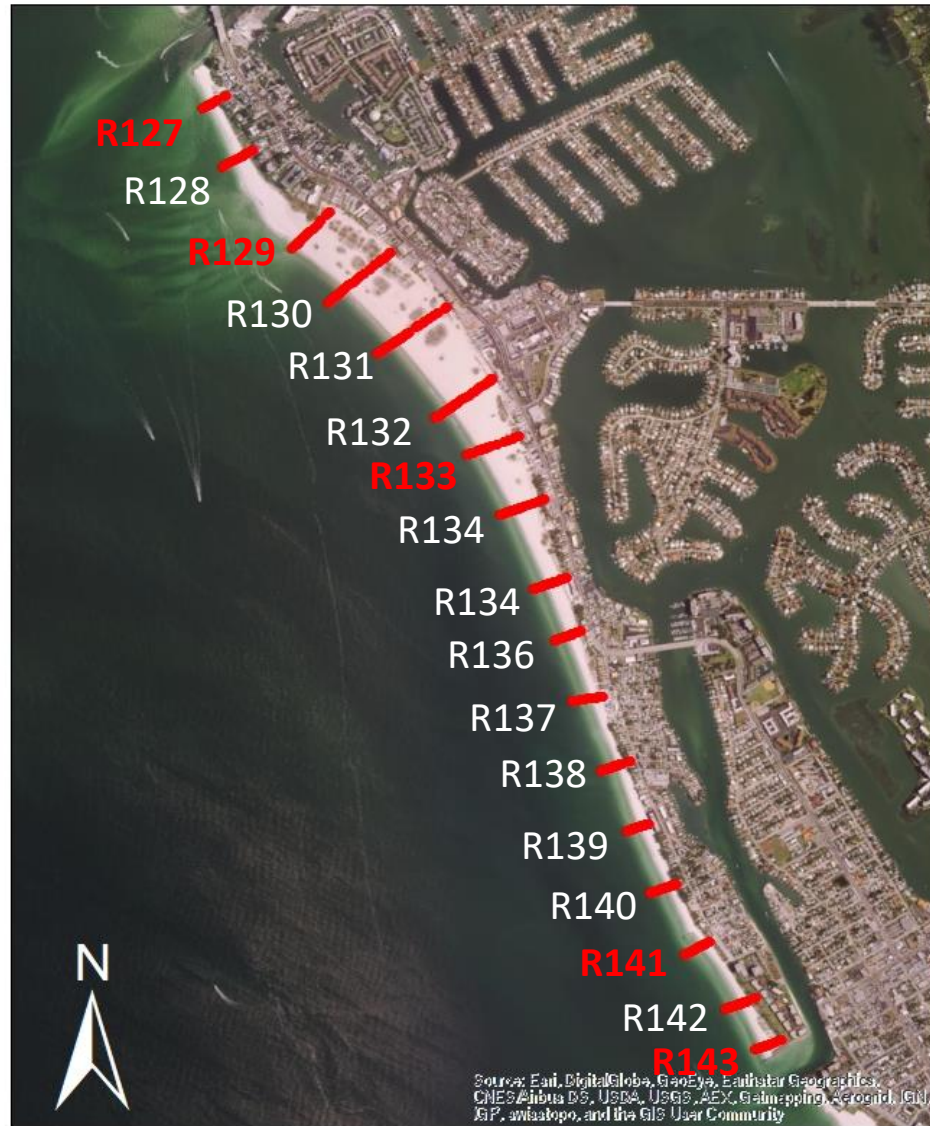
**Figure 5.** Seventeen profiles at Treasure Island from R127 at the north end to R143 at the south end.

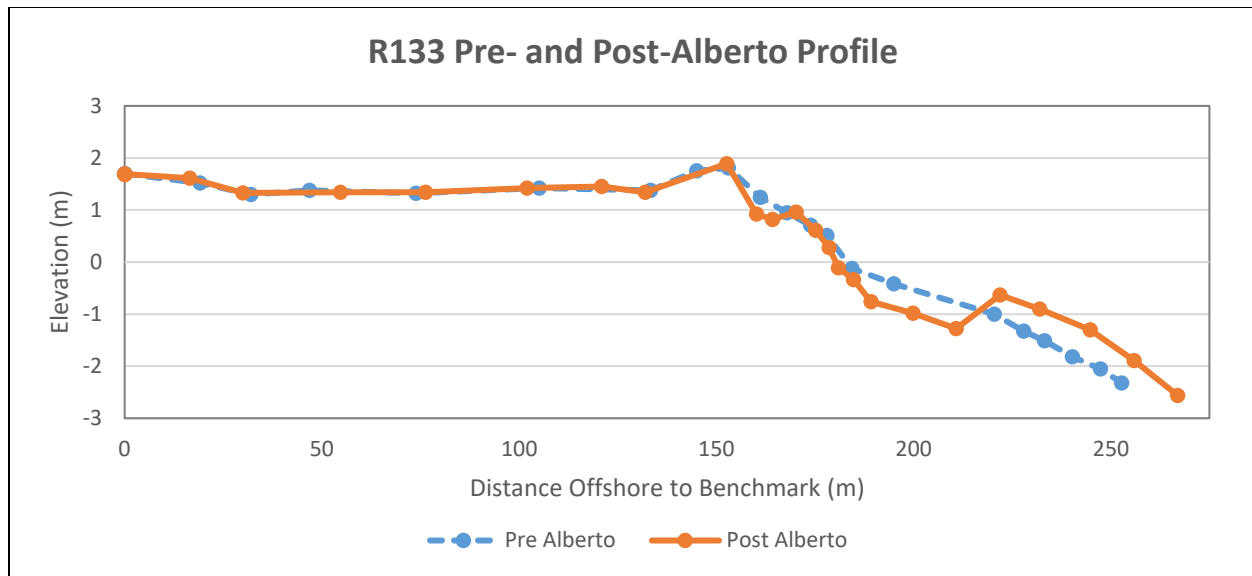
**Figure 6.** An example of beach profile pre- and post-tropical storm Alberto, 2006.

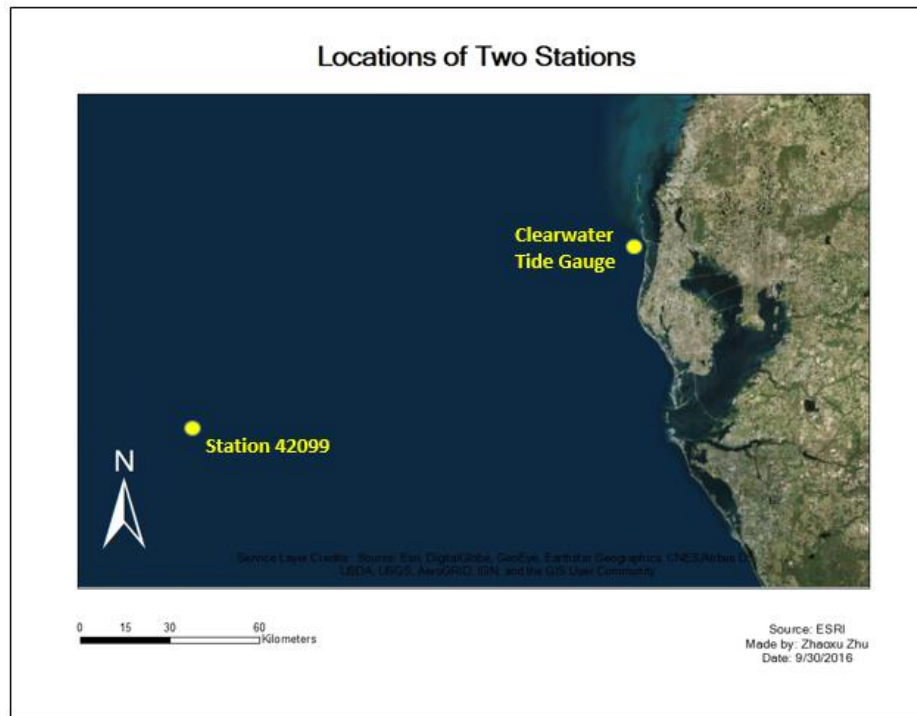
**Figure 7.** Locations of Clearwater water tide gauge and Station 42099.

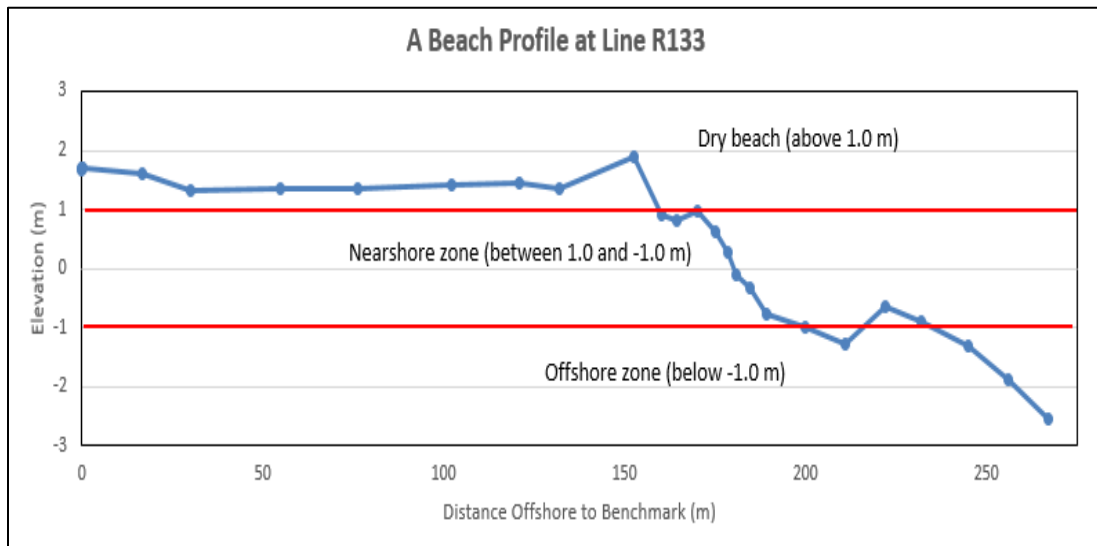
**Figure 8.** An example of beach profile at survey line R133 shows the contour levels. Dry beach is considered as the section above 1.0 m; the nearshore zone is considered the section between 1.0 and -1.0 m; and the offshore area is considered as the section below -1.0 m.

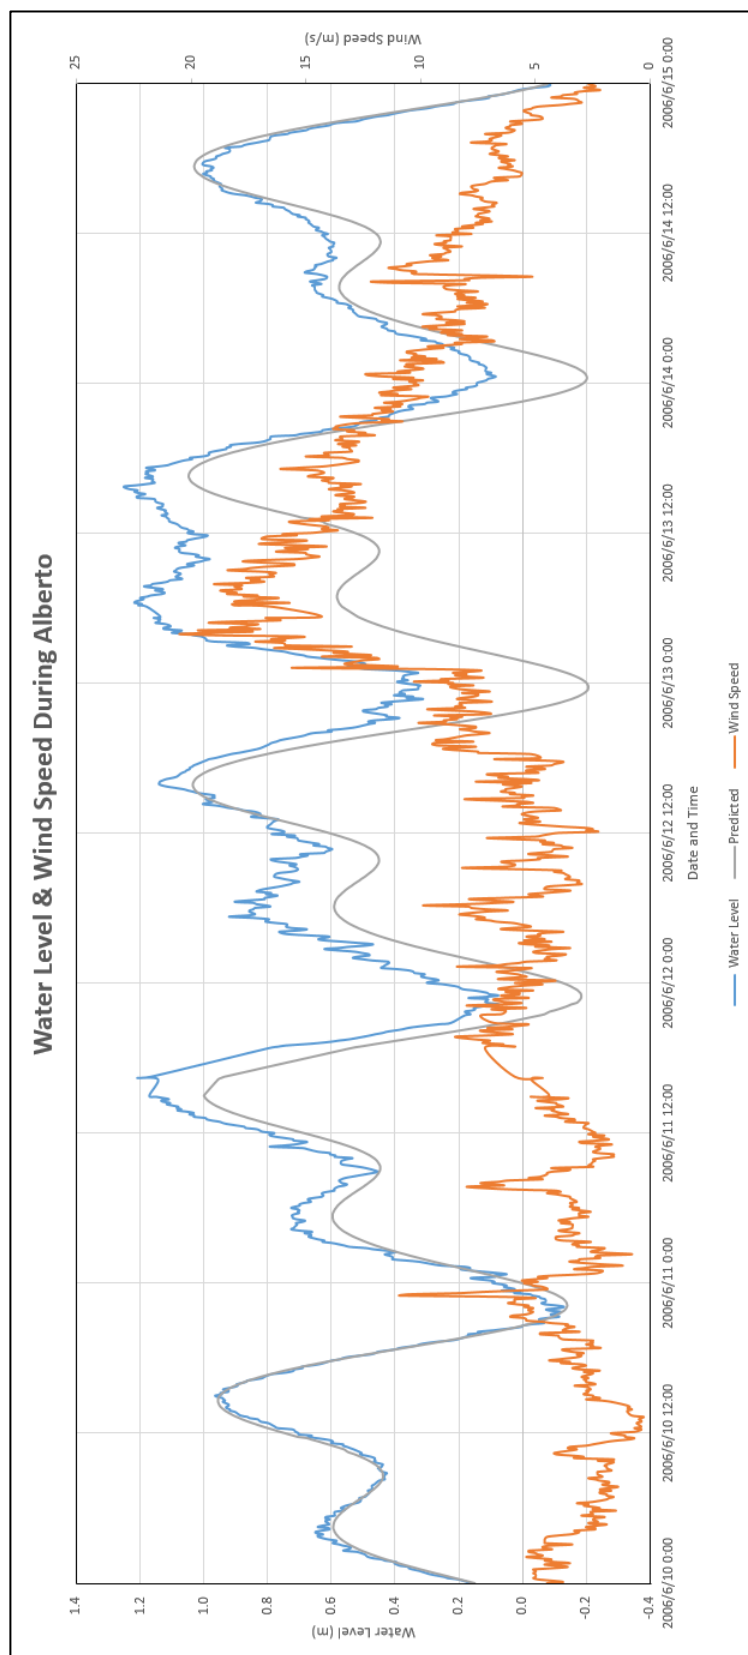
**Figure 10.** Water level and wind speed during tropical storm Alberto, 10-15 June, 2006.

Tropical storm Alberto generated strong wind speeds with a mean speed of 7.11 m/s and a peak storm surge was 0.73 m. Wind conditions and water level are showed in Figure 10. The maximum wind speed during the storm reached 20.5 m/s. During the one month pre-storm period, the mean wind speed was 4.74 m/s and the peak surge was 0.18 m. Figure 11 illustrate the wind condition and water level before Alberto. Comparing these two sets of data, the mean wind speed increased 49.97% and the peak storm surge increased approximately 3 times. Pre-storm surge and wind speed are regarded as normal conditions. In this case, over that period time of pre-

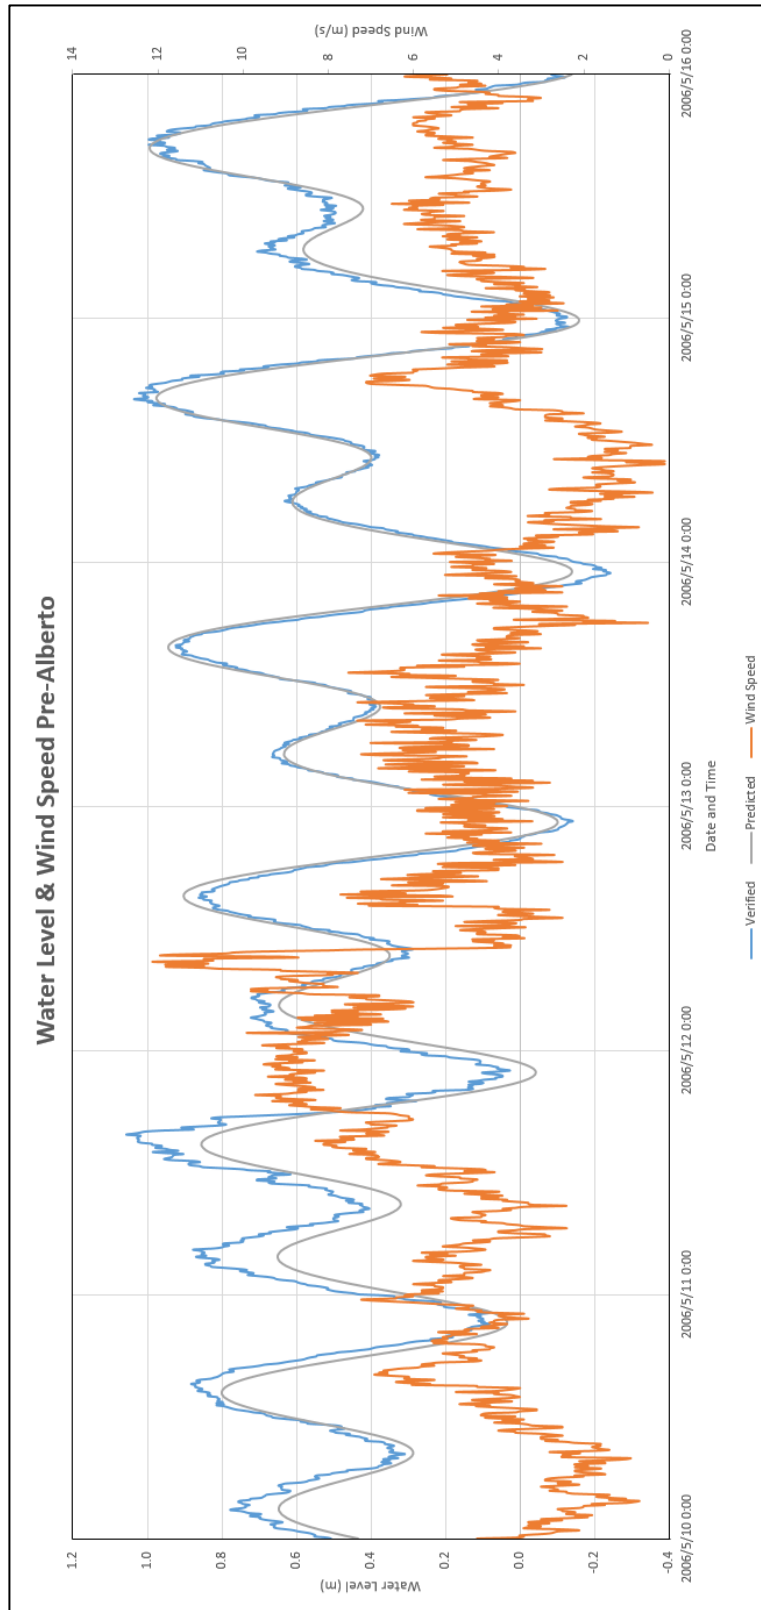
**Figure 11.** Water level and wind speed pre- tropical storm Alberto, 10-15 May, 2006.

storm, measured water level could almost match the predicted water level. On May 11, wind speeds increased to around 6 m/s. Because of a significant wind speed increase between June 11 to 14, storm surge increased to a maximum value on June 13 at approximately 6:00 a.m.

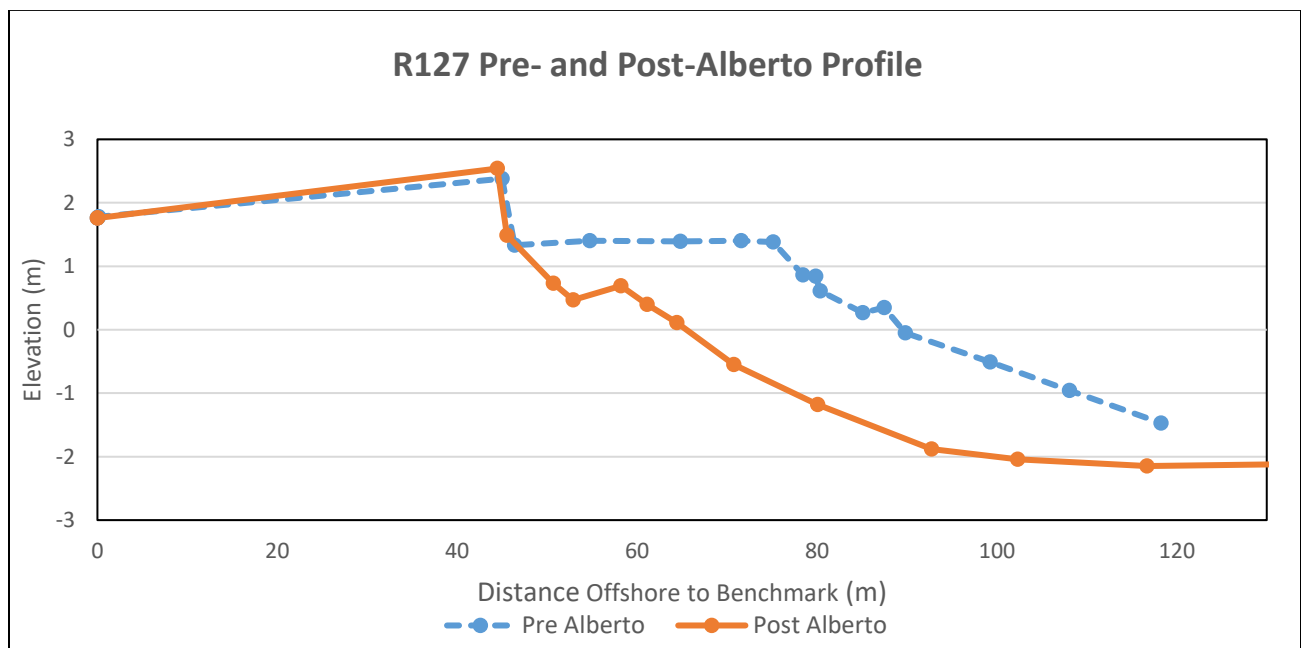
**Figure 12.** Beach profile changes at survey line R127 due to Alberto.

Profile R127 experienced erosion during the storm as shown in Figure 12. A comparison of beach profile R127 before and after tropical storm Alberto indicates that the contour line of dry beach retreated approximately 24 m landward at the elevation of 1.0 m; at the elevation of 0.0 m, the contour line moved approximately 24 m landward; and at the elevation of -1.0 m, the contour line moved approximately 24 m landward as well. These measurement indicate that the entire profile shifted landward. The measured sand loss was approximately 80 m<sup>3</sup>/m.

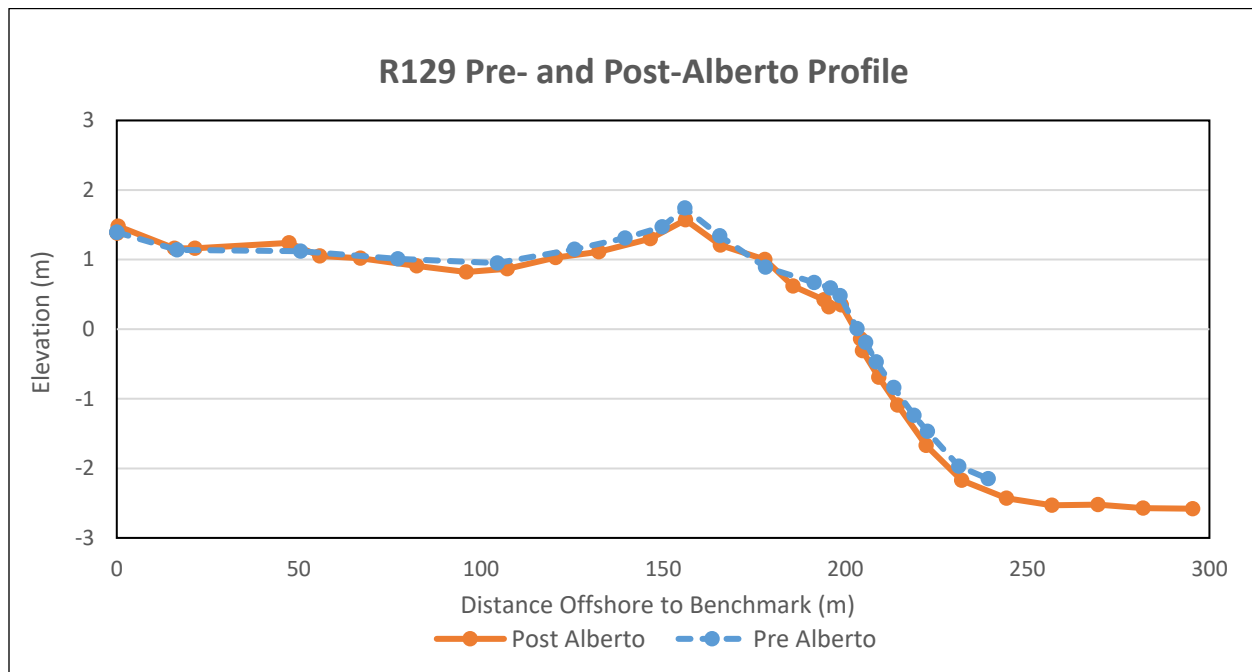
**Figure 13.** Beach profile change at survey line R129 due to Alberto.

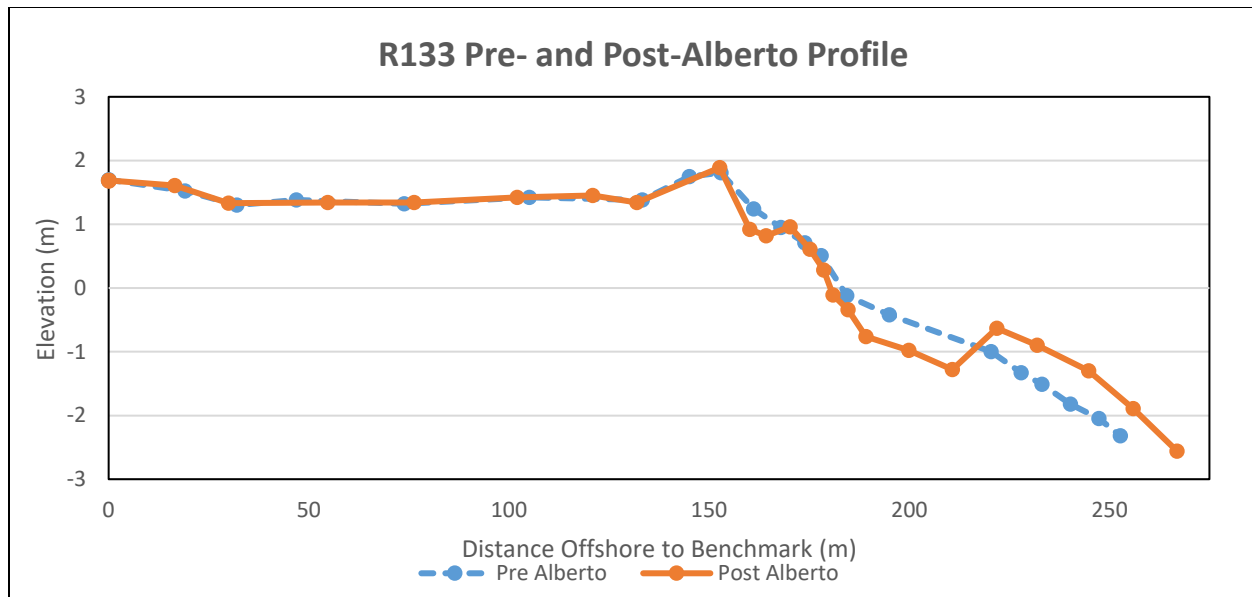
**Figure 14.** Beach profile change at survey line R133 due to Alberto.

Survey line R133 located at the Middle Beach had a 150-meter wide dry beach. According to the pre- and post-storm beach profiles (Figure 14), severe erosion occurred at this section approximately 150 to 200 m away from benchmark, and a sand bar was formed offshore approximately 225 m away from benchmark. At the elevation of 1.0 m, the contour line moved landward approximately 10 m; at the elevation of 0.0 m, the shoreline moved landward approximately 3.4 m; and at the elevation of -1.0 m, the contour line moved landward approximately 20.5 m. The measured sand volume loss was approximately 40 m<sup>3</sup>/m.

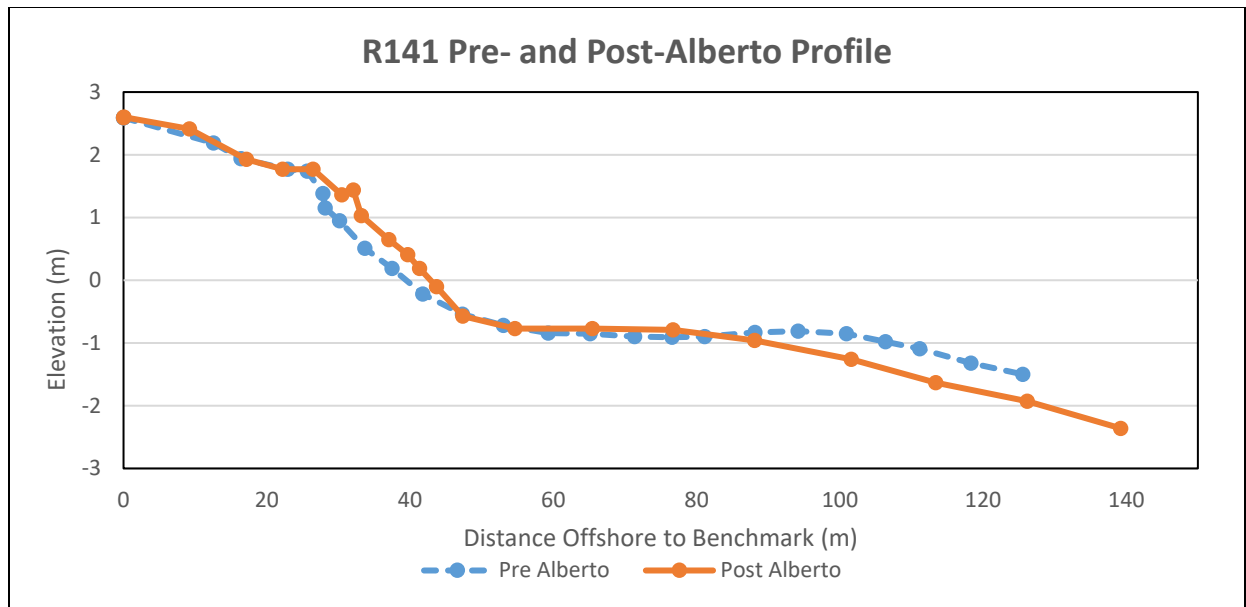
**Figure 15.** Beach profile change at survey line R141 due to Alberto.

Survey lines R141 and R143 are located at Sunset Beach, the southernmost part of Treasure Island. As mentioned in Chapter 2, the offshore dredged pit directly seaward of these two profiles resulted in higher wave heights as compared to those from adjacent area (Roberts and Wang, 2012). As a result, beach erosion here tends to be more severe than other parts of Treasure Island. However, a nourishment project was conducted from R136 to R141 during the storm. The beach profile at survey line R141 (Figure 15) shows that the contour line of the nearshore section moved seaward and the contour line at offshore section moved landward. At the elevation of 1.0 m, the contour line moved seaward approximately 3 m due to the nourishment project; at the elevation of 0.0 m, the contour line moved seaward approximately 3 m as well; however, at the elevation of -1.0 m, the contour line retreated approximately 18 m. A total measured sand loss at the offshore section was approximately  $14 \text{ m}^3/\text{m}$ . This beach change was influenced by the beach nourishment, as well as by the storm.

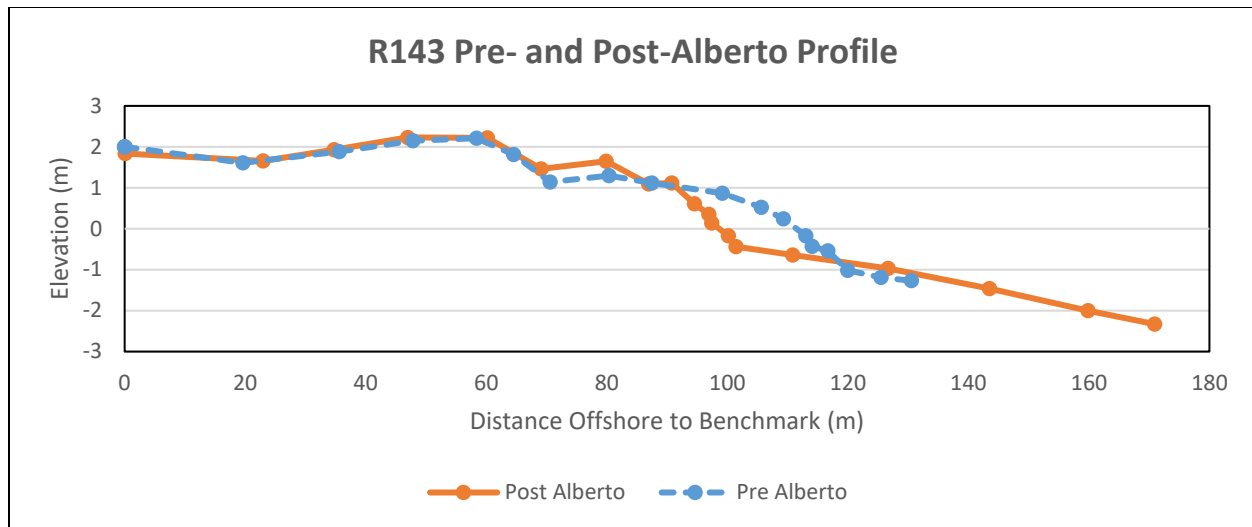
**Figure 16.** Beach profile change at survey line R143 due to Alberto.

Overall, as a result of induced by tropical storm Alberto, Treasure Island's coast was severely eroded at survey lines R127 and R143. At the elevation of 0.0 m, contour lines at survey lines R127 and R143 retreated approximately 24 m and 13 m, respectively. The contour line of profile R133 at the elevation of 0.0 m retreated approximately 3.4 m. Survey lines R129 and R141 experienced relatively small amounts of erosion according to pre- and post-storm beach profiles. However, these two sections may have experienced severe erosion just as what happened at survey lines R127 and R143. The erosion at these two sections may have been compensated by the ongoing nourishment projects.

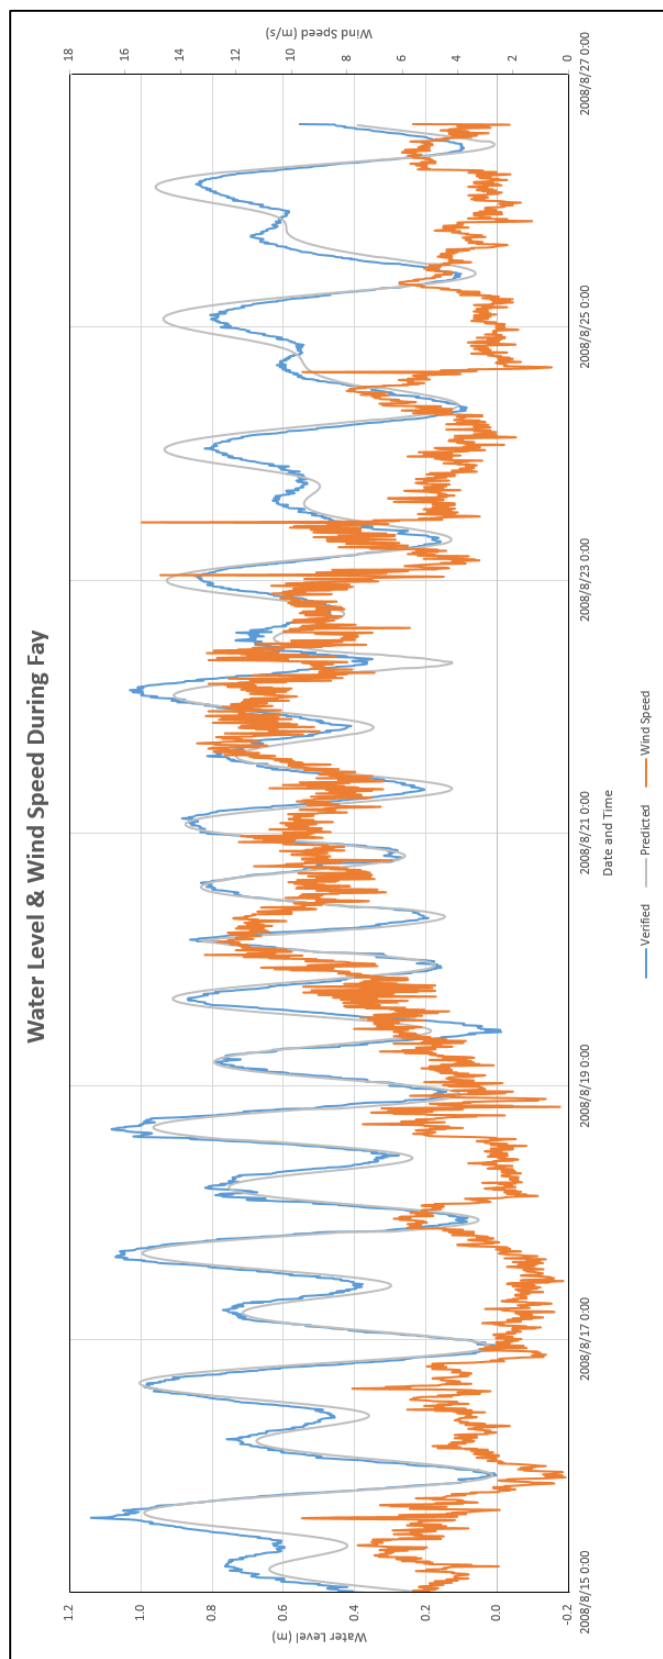
**Figure 18.** Water level and wind speed during tropical storm Fay, 15-27 August, 2008.

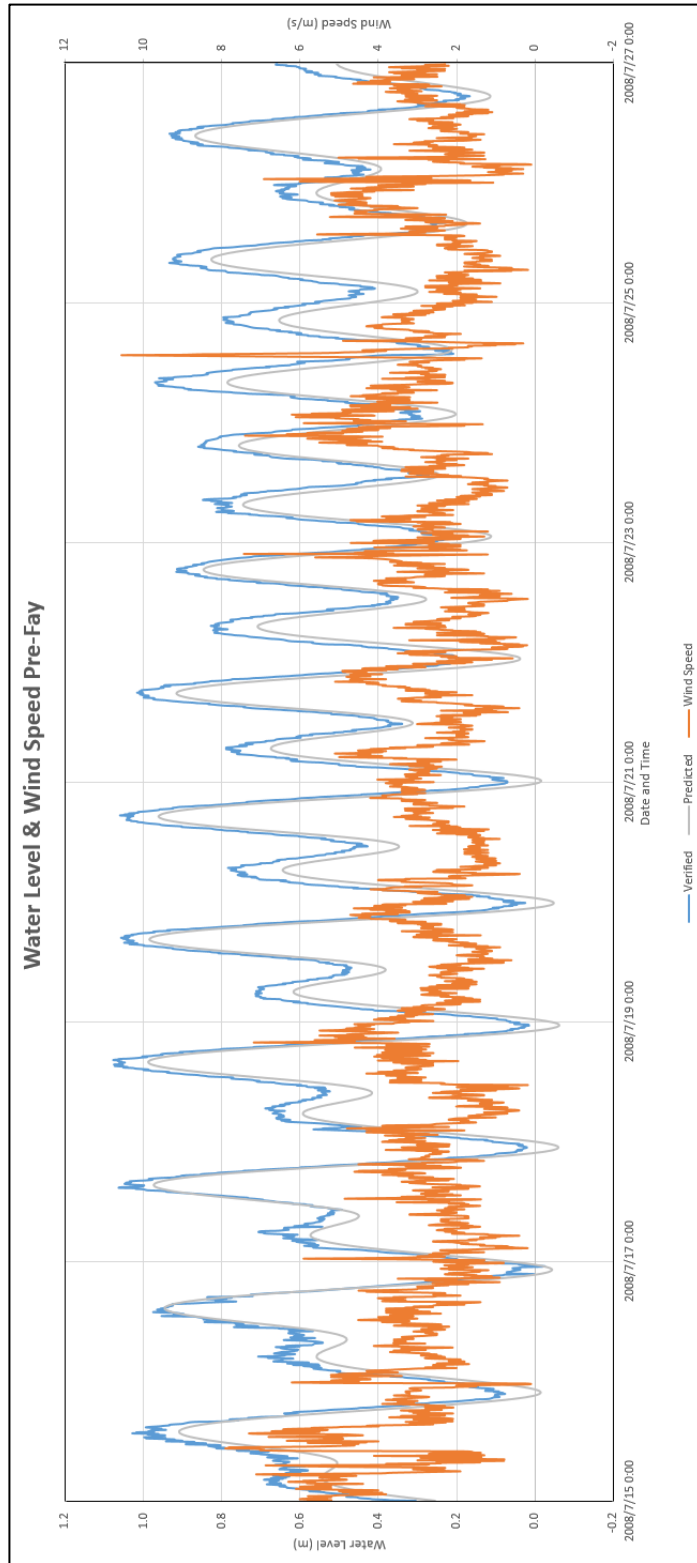
**Figure 19.** Water level and wind speed pre-tropical storm Fay, 15-27 July, 2008.

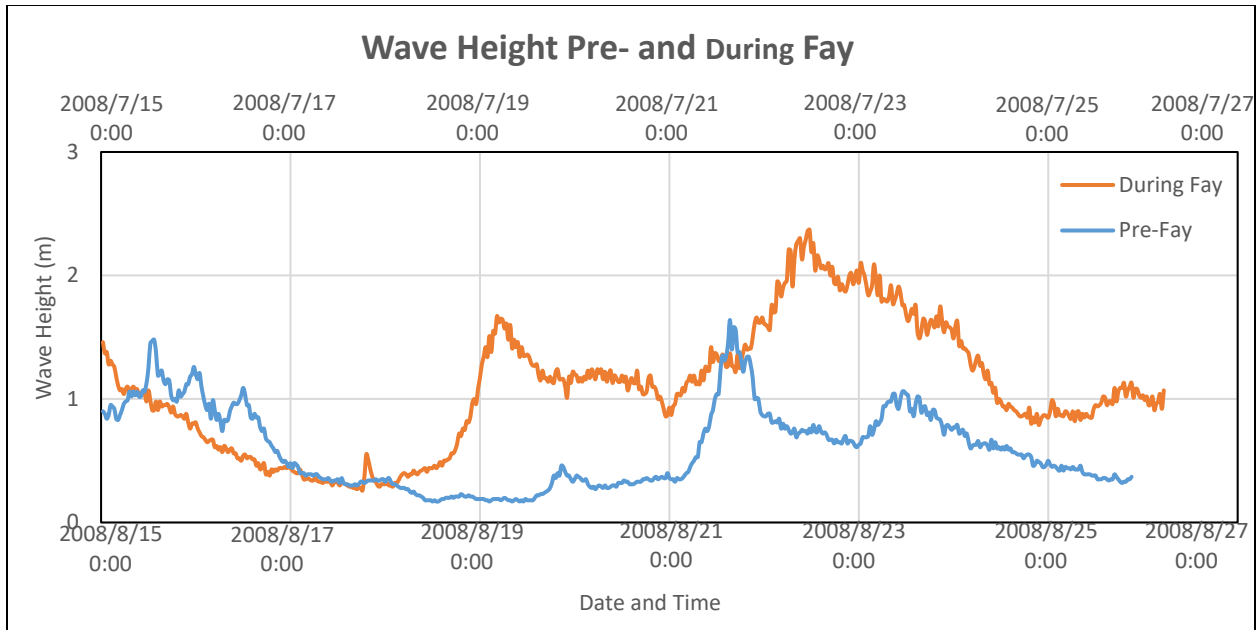
**Figure 20.** Wave height pre- and during Fay, measured at Station 42099 by NOAA's NDBC.

Due to Fay's complicated path and landfall area, water level and storm surge may not be good controlling factors of storm impact on the beach changes in the study area. Therefore, wave height is discussed here as another controlling factor (Figure 20, see page 32). Wave height increased rapidly on August 19 and remained over 1 m for 5 days between August 19 and August 24, 2008. When Fay moved seaward into the Gulf of Mexico, wave heights reached up to 2.37 m around 11:00 a.m. on August 22. After Fay moved away, wave height decreased to approximately 1 m.

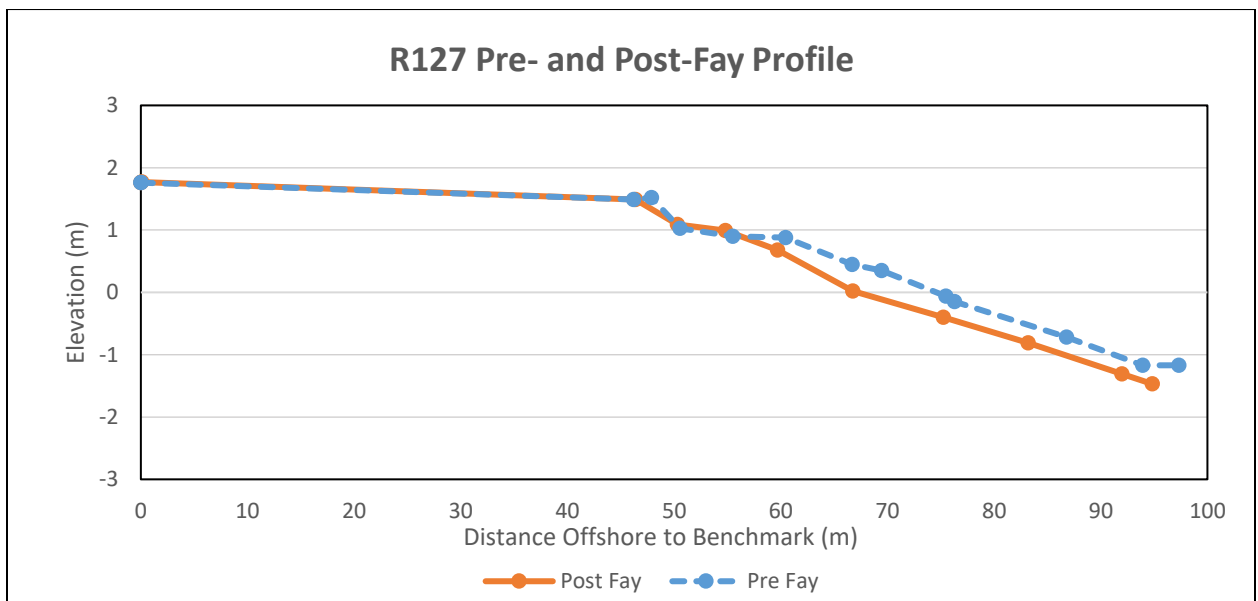
**Figure 21.** Beach profile change at survey line R127 due to Fay.

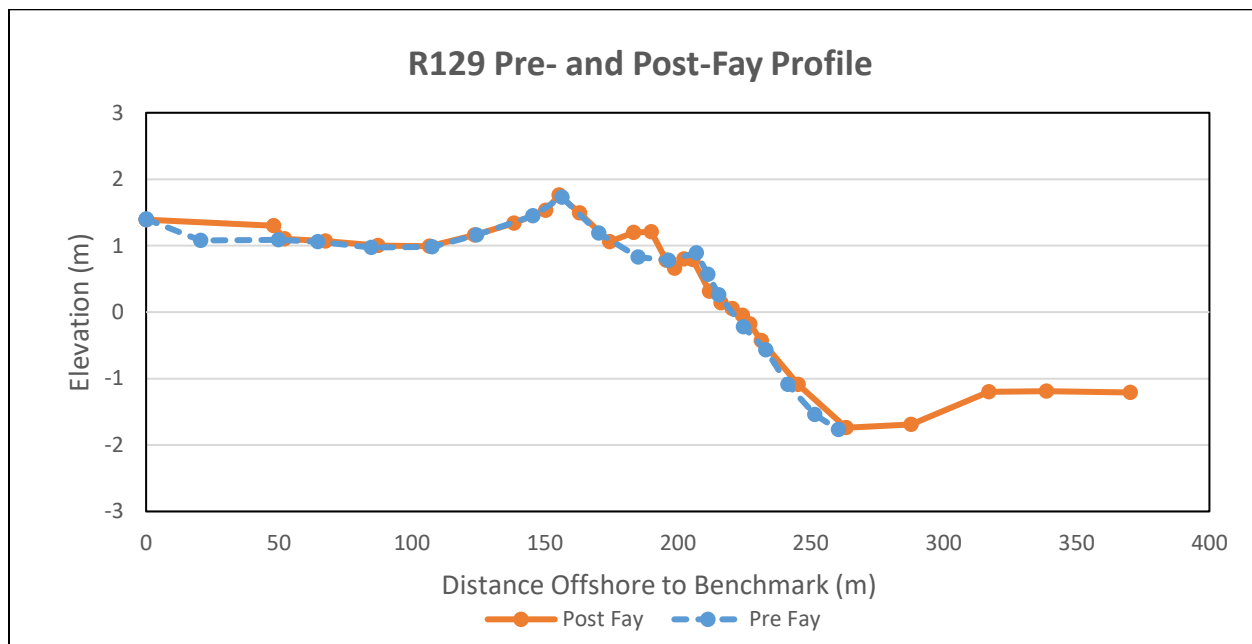
**Figure 22.** Beach profile at survey line R129 due to Fay.

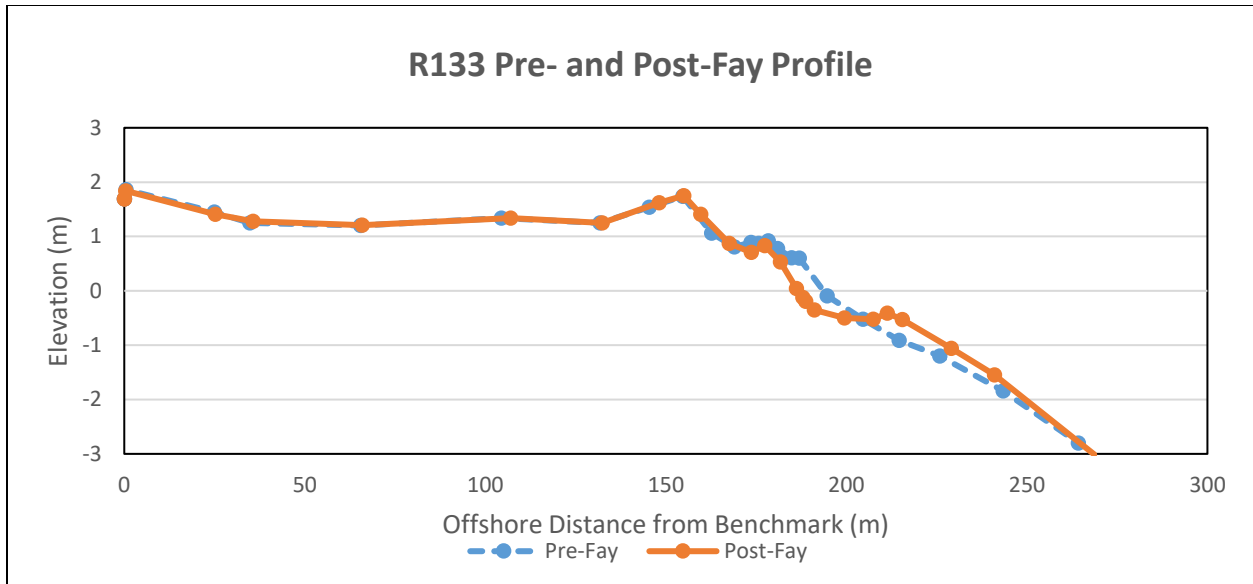
**Figure 23.** Beach profile change at survey line R133 due to Fay.

No significant erosion occurred at profile R133 (Figure 23). There was no significant change to dry beach and dune area. The nearshore zone at the section from 180 to 200 m away from benchmark lost a small amount of sand. At an elevation of 0.0 m, the contour line move landward approximately 5 m. At the offshore area, from location of 210 to 250 m away from the benchmark, a small amount of deposition was gained, which balanced the sand loss in the nearshore zone.

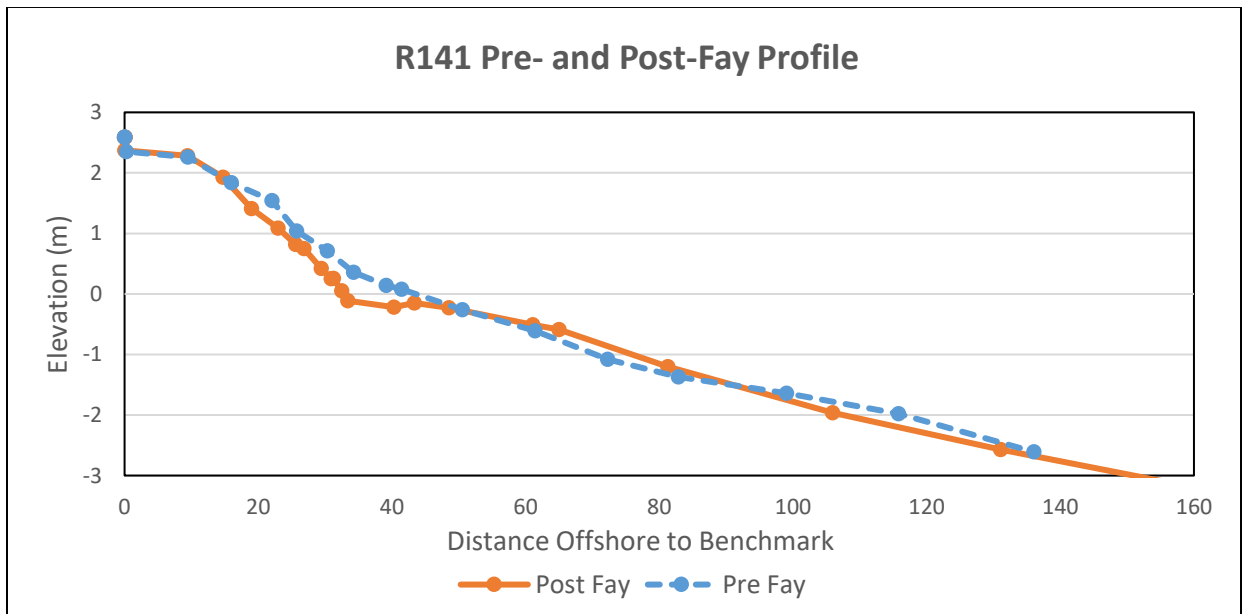
**Figure 24.** Beach profile change at survey line R141 due to Fay.

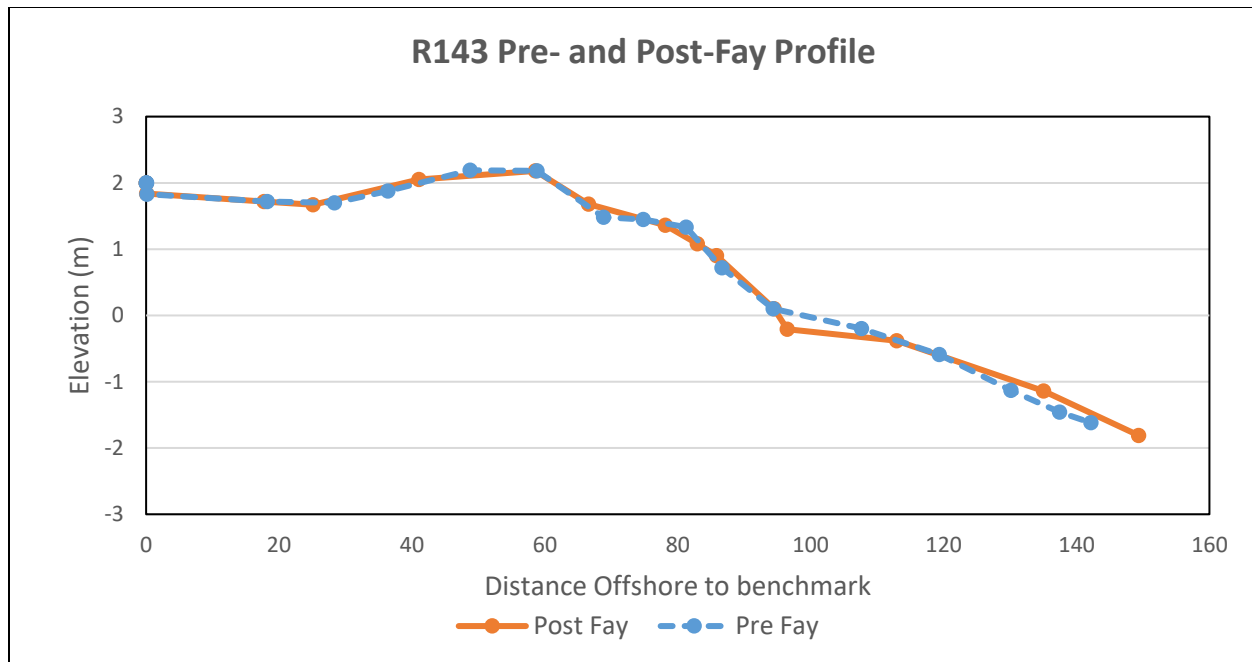
**Figure 25.** Beach profile change at survey line R143 due to Fay.
